OCTOBER 2015
www.craneworld.com
A KHL Group publication

Lifting in tandem

In this month's feature, MARCO VAN DAAL highlights a tandem lift recently performed at a concrete facility

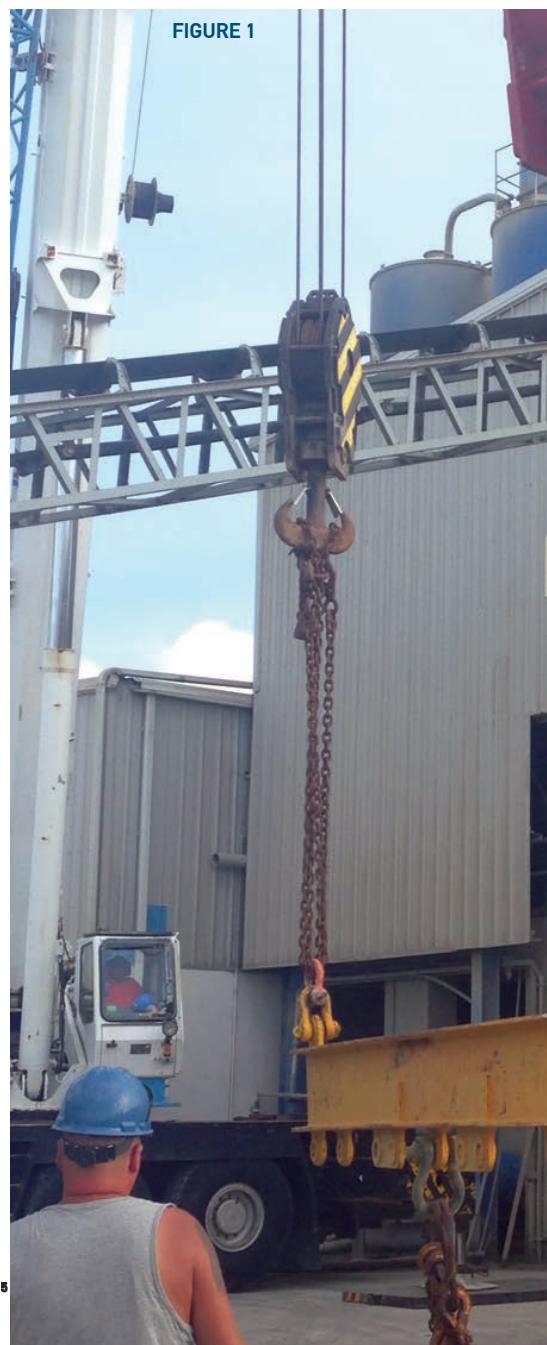
FIGURE 1

OPTION 3: This option entailed leaving the lifting eyes untouched and use a lift beam long enough to keep the boom heads away from each other. The silo would be suspended from a single centre lifting lug so that a difference in hoisting speed would not affect the load of either one of the cranes. The silo would also remain level at all times. This option was selected as the best way to perform the lift. See Figure 1 for the rigging arrangement at ground level.

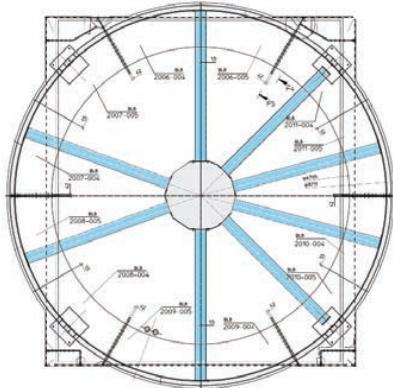
FIGURE 2

These raw materials are needed in different quantities and, therefore, the various compartments are of different sizes. Figure 2 is a section of the construction drawings and shows the compartment walls in blue. On the right side of the drawing there are two additional compartment walls and therefore the CoG of the silo is slightly towards the right.

This silo was designed to function as a batching silo. A batching silo holds various components (raw materials) in the different silo compartments. These components are added to the mix that results in a concrete batch of a certain quality and strength.

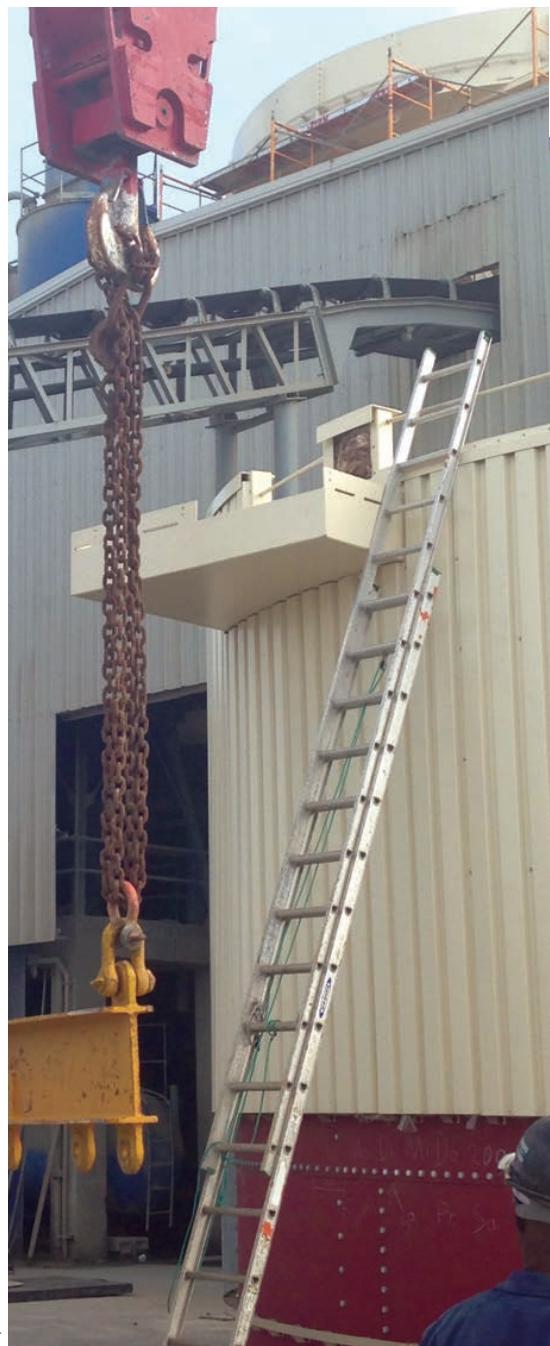
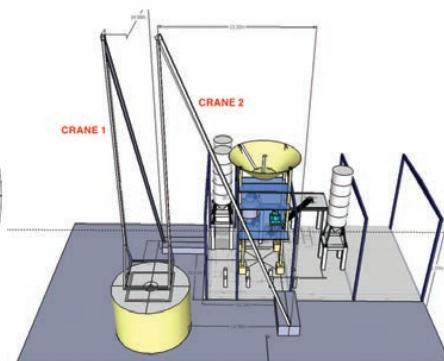
FIGURE 3

Abandoning the lift (at any stage) would set back the schedule and that was to be avoided. Figure 3 (initial position) and Figure 4 (final position) show the result of this exercise.

For both cranes the initial and final radii were determined and documented:

Crane 1 initial radius: 14.99 m

Crane 1 final radius: 11.06 m

Crane 2 initial radius: 13.32 m

Crane 2 final radius: 14.01 m

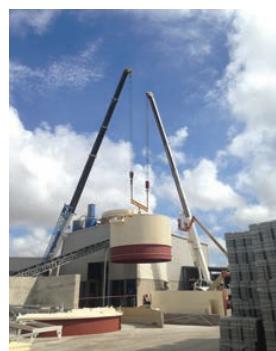
FIGURE 7

At around 08.00 the lift commenced. Figure 7 shows the lift in process, the silo lifted to about half the height of the building. In Figure 8 the silo is being slewed over the earlier installed silo legs. Figure 9 shows the silo almost lining up with its support structure.

During the slewing operation the lift supervisor received feedback from the spotters about the plumbness of the lifting wire of each of the cranes. In each of these figures you can see the man lift that was used by the lift supervisor to ensure that all obstacles and obstructions were cleared.

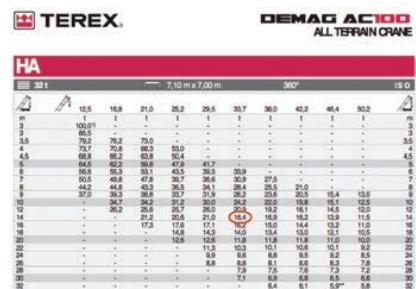
FIGURE 5

From manufacturers load charts, as shown in Figure 5 and Figure 6 and the reduction of the rated capacity, the below overview can be made. In this scenario neither crane exceeds 85 % of its rated capacity. Refer to table above.

CAPACITY	REDUCED CAPACITY (85 %)
Crane 1, Grove, initial radius:	14.99 m	20.5 tonne
Crane 1, Grove, final radius:	11.06 m	29.5 tonne
Crane 2, Terex, initial radius:	13.32 m	18.4 tonne
Crane 2, Terex, final radius:	14.01 m	18.4 tonne
		15.6 tonne
		15.6 tonne
